# TELEVISION INSPECTION

Line Segment: (FC09) P18 NE107

Location: FAS NITE PARK

**To:** Lyman, Randy; Dotson, Art; 'pmelgren@ghnae.com'  
**Cc:** Pabst, Gene  
**Subject:** RE: Fassnight Pool Project

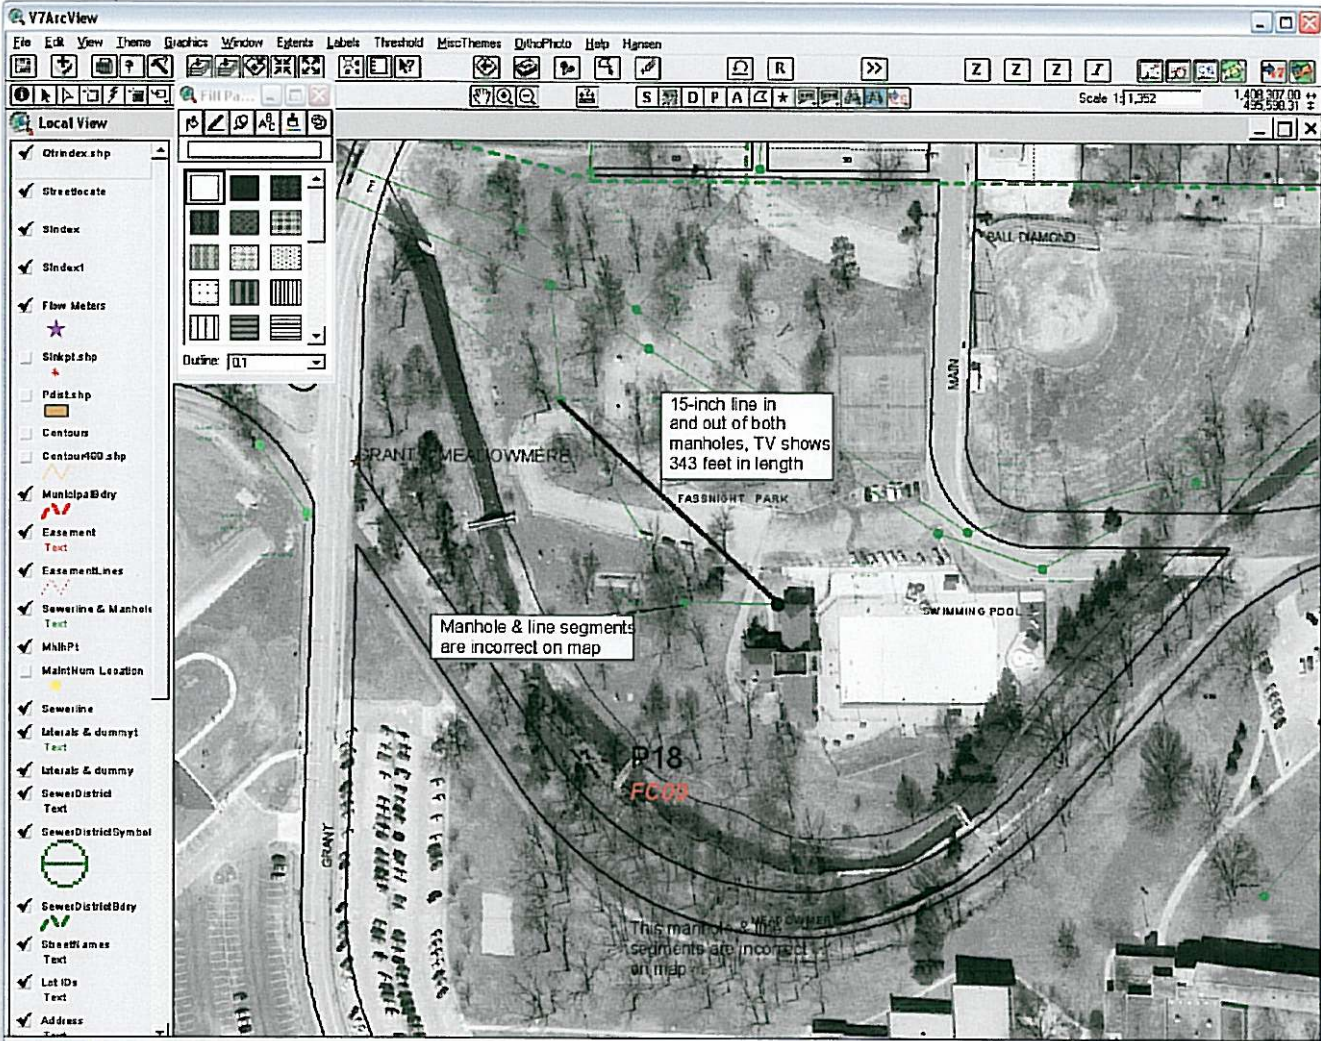
Here is the map with new information after field inspection. The map is wrong as noted on the attached document.

field verify pipe inlets and outlet sizes, invert thru manhole?
